**Calusa Point Association**  
***Miami, FL***

Report #: 29086-2  
Beginning: January 1, 2023  
Expires: December 31, 2023

**RESERVE STUDY**  
**Update "With-Site-Visit"**

October 26, 2022

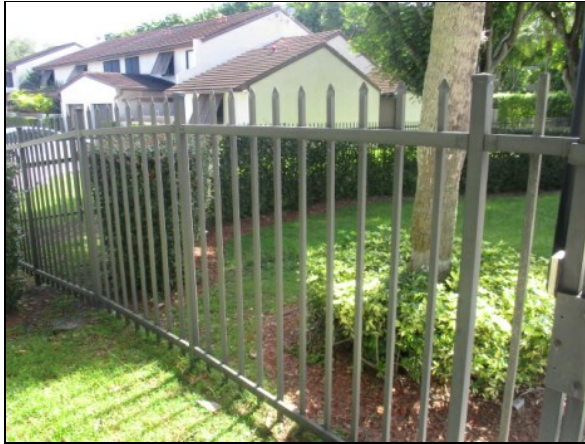
In our experience, metal fencing will typically eventually break down due to a combination of sun and weather exposure, which is sometimes exacerbated by other factors such as irrigation overspray, abuse and lack of preventive maintenance. For some types of fencing, complete replacement is advisable over minor repairs paired with recoating or refinishing due to relatively short lifespan of coatings and consideration of total life-cycle cost.

Useful Life:  
25 yearsRemaining Life:  
0 years

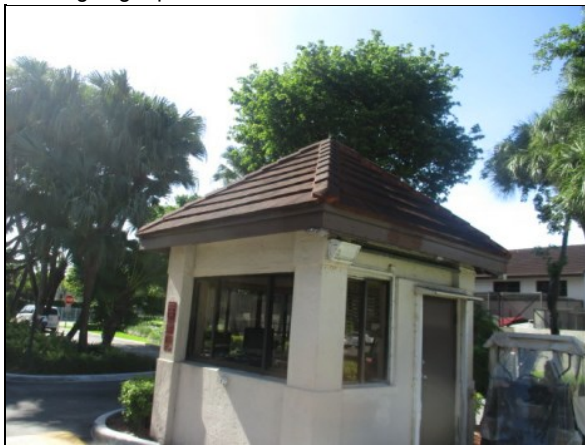
All are assumed to have been compliant with applicable building codes at time of installation. Inspect regularly for leaks and cracks around frame and repair as needed. For operable windows, clean tracks and ensure hardware is functional to prevent accidental damage during opening/closing. With ordinary care and maintenance, useful life is typically long but often difficult to predict. Many factors affect useful life including quality of window currently installed, waterproofing details, exposure to wind and rain, etc. Individual windows and doors may be replaced as an Operating expense if damaged or broken, or using Reserve funds if cost is significant. An allowance for ongoing replacements is recommended here.

Useful Life:  
10 yearsRemaining Life:  
0 years
