Calusa Point Association *Miami, FL*

Report #: 29086-3
Beginning: January 1, 2025
Expires: December 31, 2025

RESERVE STUDY Update "With-Site-Visit"

May 29, 2024

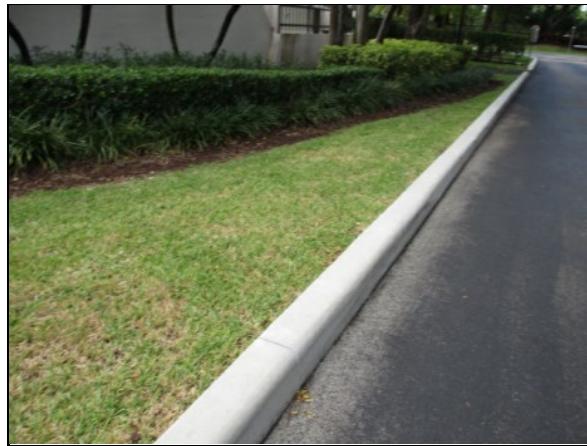
Comp #: 2109 Concrete Curbs & Gutters - Repair

History: Replaced in 2021 for \$231,728.31 (per information provided)

Useful Life:
40 years

Remaining Life:
36 years

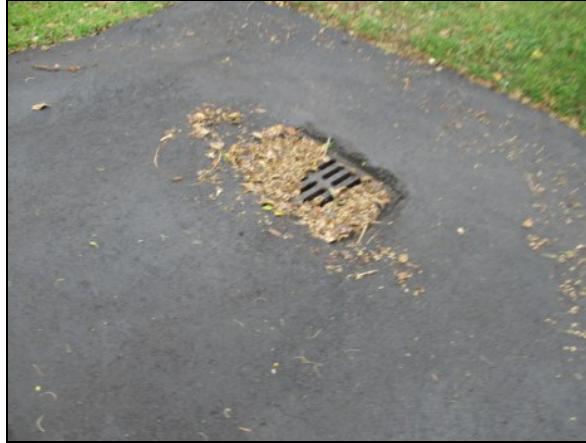
Comments: As this was a visual inspection only, there was no access nor capability to inspect in-ground drainage infrastructure comprehensively. Annual preventive maintenance work is typically performed as part of a Client's general maintenance/operating fund. Under normal circumstances, site drainage components are constructed of very durable materials which should have a very long useful life (often assumed to be 50 years or more). Based on observed conditions and/or information provided by the Client, this component represents a rotating "supplemental" allowance for larger repair projects that may occur. We recommend that the Client consult with a qualified engineer or vendor to determine potential project repair timelines and cost. Further investigation such as cameras or other means are used identify existing conditions. Professional findings and repair history should be tracked and reported by the Client during future Reserve Study updates. This component should then be re-evaluated based on the most current information available at that time.

Useful Life:
20 yearsRemaining Life:
16 years

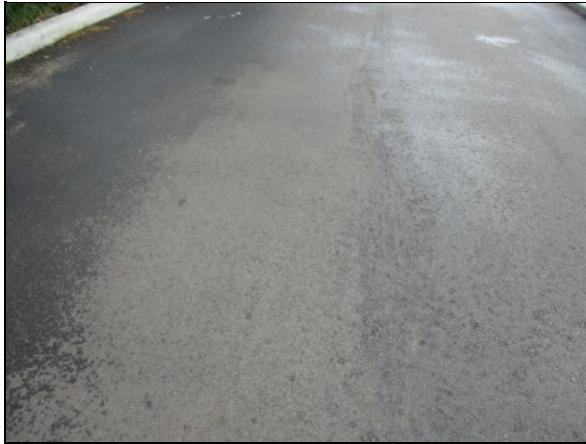
Useful Life:
20 yearsRemaining Life:
16 years

As routine maintenance, keep roadway clean, free of debris and well drained; fill/seal cracks to prevent water from penetrating into the sub-base and accelerating damage. Even with ordinary care and maintenance, plan for eventual large scale resurface (milling and overlay of all asphalt surfaces is recommended here, unless otherwise noted) at roughly the time frame below. Take note of any areas of ponding water or other drainage concerns, and incorporate repairs into scope of work for resurfacing. Our inspection is visual only and does not incorporate any core sampling or other testing, which may be advisable when asphalt is nearing end of useful life. Some communities choose to work with independent paving consultants or engineering firms in order to identify any hidden concerns and develop scope of work prior to bidding. If more comprehensive analysis becomes available, incorporate findings into future Reserve Study updates as appropriate.

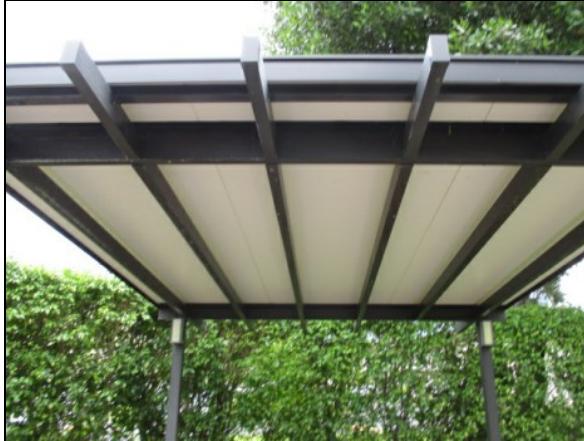
Useful Life:
20 yearsRemaining Life:
12 years

As routine maintenance, inspect regularly and repair individual pieces or sections as needed from general Operating funds. Clean and paint/stain along with other larger projects or as general maintenance to preserve the appearance of the gazebo and extend its useful life. If present, vegetation should be well-maintained and not allowed to become overgrown, which can eventually compromise the structure. Assuming ordinary care and maintenance, plan for major repairs or possibly complete replacement (if warranted) at roughly the interval indicated below.

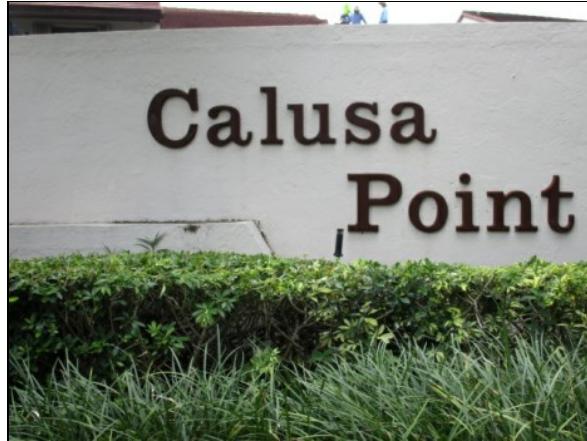
Useful Life:
15 yearsRemaining Life:
5 years

As routine maintenance, inspect regularly, clean/touch-up and repair as an Operating expense. Plan to refurbish or replace at the interval below. Timing and scope of refurbishing or replacement projects is subjective but should always be scheduled in order to maintain good curb appeal. In our experience, most Associations choose to refurbish or replace signage periodically in order to maintain good appearance and aesthetics in keeping with local area, often before signage is in poor physical condition. If present, concrete walls are expected to be painted and repaired as part of refurbishing, but not fully replaced unless otherwise noted. Costs can vary significantly depending on style/type desired, and may include additional costs for design work, landscaping, lighting, water features, etc. Reserve Study updates should incorporate any estimates or information collected regarding potential projects.

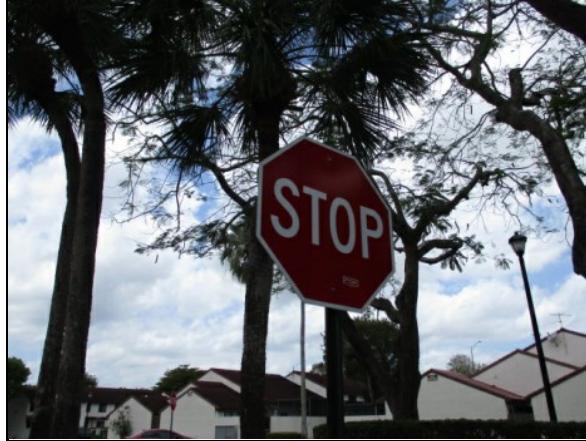
Useful Life:
20 yearsRemaining Life:
16 years

Signs should be inspected regularly to make sure visibility is adequate, including at night. Repair any damaged or leaning posts as needed. Individual sign replacement costs are expected to be handled through the Operating budget. Street signs and posts are generally replaced at longer intervals due to weathering or style changes, or to coincide with other exterior projects such as replacement of entry signage, street lighting, etc. Costs for replacement can vary greatly depending on style selected; unless otherwise noted, costs shown here are based on comprehensive replacement with a comparable type as are currently in place.

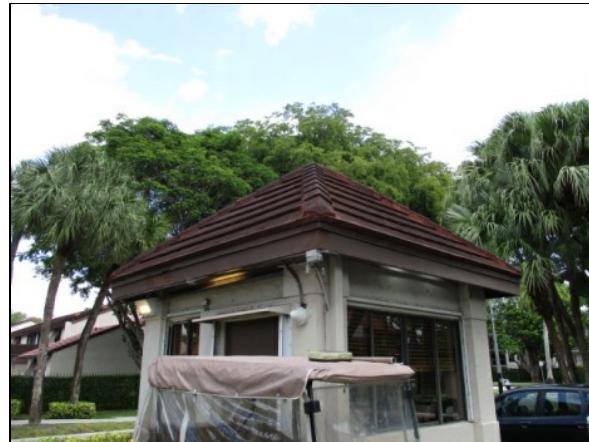
Tile roofing is typically a long-lived component assuming it was properly installed and is properly maintained. The primary reason to replace tile roofs is not based on the condition of the tiles themselves, whose main purpose is to provide a barrier for the underlayment which is the actual waterproofing layer of the roof system. As such, the timeline for tile roof replacement is generally estimated based on the age of the roof. As routine maintenance, many manufacturers recommend inspections at least twice annually and after large storm events. Promptly replace any damaged/missing sections or conduct any other repair needed to ensure waterproof integrity of roof. We recommend having roof inspected in greater detail (including conditions of sub-surface materials) by an independent roofing consultant prior to replacement. There is a wealth of information available through organizations such as the Roof Consultant Institute <http://www.rci-online.org/> and the National Roofing Contractors Assn. (NRCA) <http://www.nrca.net/>. If the roof has a warranty, be sure to review terms and conduct proper inspections/repairs as needed to keep warranty in force. Remaining useful life is typically based on roof age, but can also be adjusted based on inspection of any accessible areas, looking for any cracked, slipping or missing tiles, as well as consultation with the Client about history of repairs and preventive maintenance. Typical replacement includes removal and replacement of tiles and underlayment, with repairs to any damaged substrate made as needed.

Useful Life:
20 years

Remaining Life:
9 years

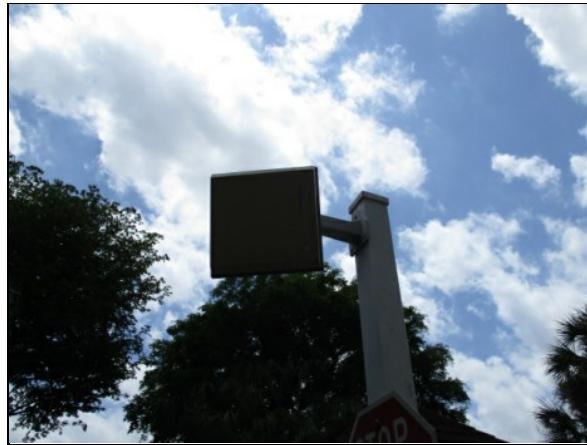
Comments: RFID sensors should be evaluated and repaired as-needed by servicing vendor to ensure proper function. Minimal or no subjective/aesthetic value for this component. Useful life is based primarily on normal expectations for service/performance life in this location. Unless otherwise noted, remaining useful life expectancy is based primarily on original installation or last replacement/purchase date, our experience with similar systems/components, and assuming normal amount of usage and good preventive maintenance. For best pricing and to minimize downtime, best practice is to replace with other similar components, such as gate operators and/or barrier arms. Cost shown is for the sensor device itself; RFID tags are assumed to be paid for by unit/homeowners.

Useful Life:
15 yearsRemaining Life:
7 years

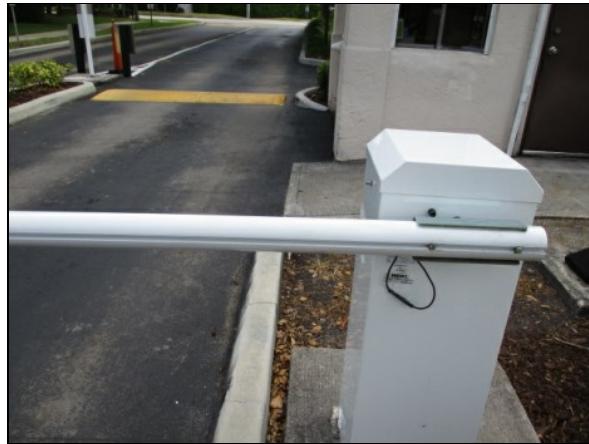
Please refer to the prior component (#2511) in this series for more general information and commentary on barrier arm operator replacement. The useful life, remaining useful life, and cost range for this specific component are provided below.

Useful Life:
15 years

Remaining Life:
10 years

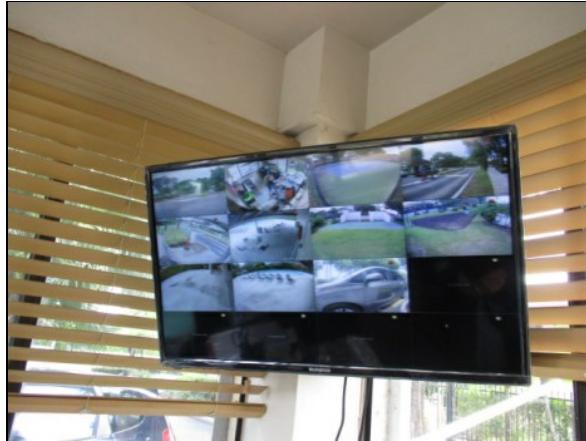
Useful Life:
10 yearsRemaining Life:
7 years

Security/surveillance systems should be monitored closely to ensure proper function. Whenever possible, camera locations should be protected and isolated to prevent tampering and/or theft. Typical modernization projects may include addition and/or replacement of cameras, recording equipment, monitors, software, etc. Unless otherwise noted, costs assume that existing wiring can be re-used and only the actual cameras and other equipment will be replaced. In many cases, replacement or modernization is warranted due to advancement in technology, not necessarily due to functional failure of the existing system. Keep track of any partial replacements and include cost history during future Reserve Study updates.

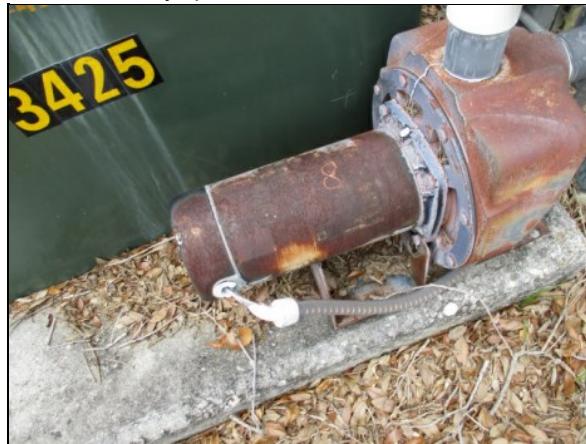
Useful Life:
3 yearsRemaining Life:
1 years

Irrigation pumps and motors need to be checked and serviced regularly by landscaping/irrigation vendor or other maintenance personnel to ensure proper function. Due to pump quantity, varying ages, and/or information provided by the Client (such as cost history), we recommend a "supplemental" allowance for ongoing motor, pump, and control repairs/replacements as-needed by the Client. Future expenditures related to this component should then be tracked and reported by the Client. This component should then be re-evaluated during future Reserve Study updates based on the most current information available at that time.

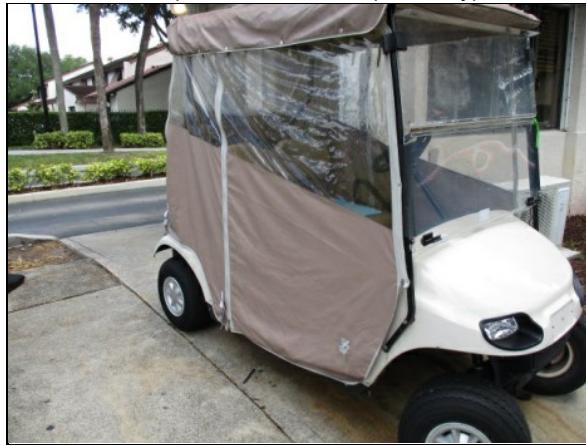
Useful Life:
10 years

Remaining Life:
2 years

Routine maintenance should be performed to maximize useful life of the cart. Useful life is based primarily on normal expectations for service/performance life in this location, but life expectancy will typically depend on geographic location, equipment application, and level of daily use. Unless otherwise noted, remaining useful life shown below is based primarily on original installation or last replacement/purchase date, our experience with similar systems/components, and assuming normal amount of usage and good preventive maintenance. Cost estimates reflect replacement with comparable type, either new or lightly used.

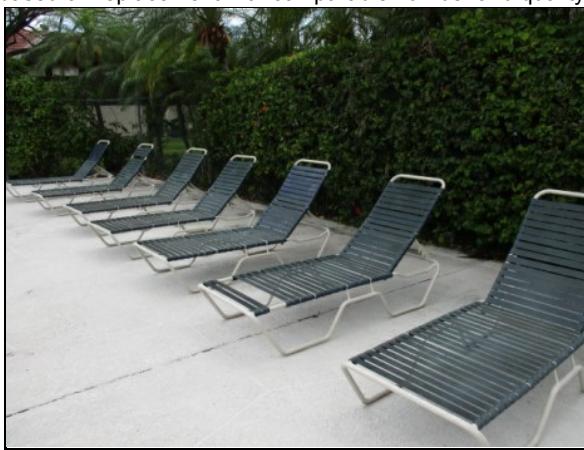
Useful Life:
8 yearsRemaining Life:
0 years

We recommend regular inspections and repair or replacement of any damaged pieces promptly to ensure safety. Protected storage of furniture when not in use can help to extend useful life. Best practice is to replace all pieces together in order to maintain consistent style and quality in the pool/recreation area. Individual pieces can be replaced as needed each year as an Operating expense. Costs can vary greatly based on quantity and type of pieces selected for replacement. Funding recommendation shown here is based on replacement with comparable number and quality of pieces as existing.

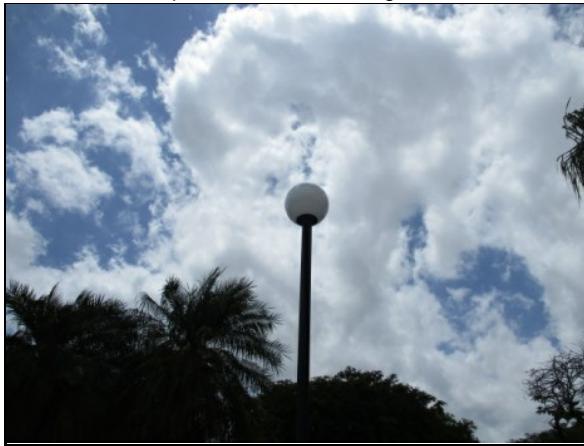
Useful Life:
25 yearsRemaining Life:
0 years

Lighting around the pool deck should be inspected regularly to ensure adequate brightness at night for safety precaution. Minor repairs and individual replacements are expected to be handled through the Operating budget. Comprehensive replacement is often coordinated with either exterior/site lighting or with other pool-related components such as decking/fencing. Cost estimates shown below are based on replacement with comparable size and design standards as existing lighting.

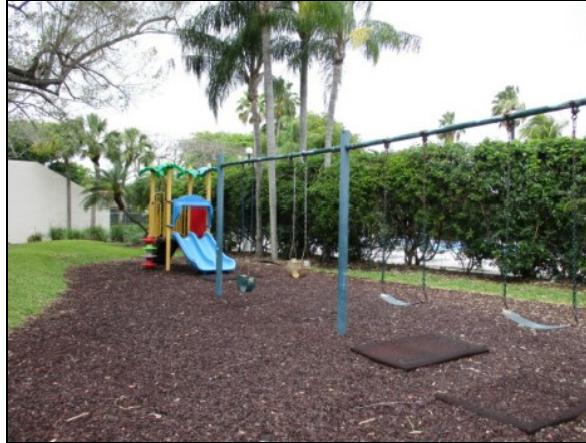
Useful Life:
25 years

Remaining Life:
17 years

As a routine maintenance expense, inspect for stability, damage and excessive wear and utilize maintenance funds for any repairs needed between replacement cycles. Our inspection is visual in nature only not intended to identify any structural or latent defects, safety hazards, or other liability concerns. Life expectancy can vary depending on the amount of use/abuse. Observations and replacement intervals shown below are strictly for budget purposes. Unless otherwise noted, cost estimates assume replacement would be with comparable size and style of equipment as noted during inspection.

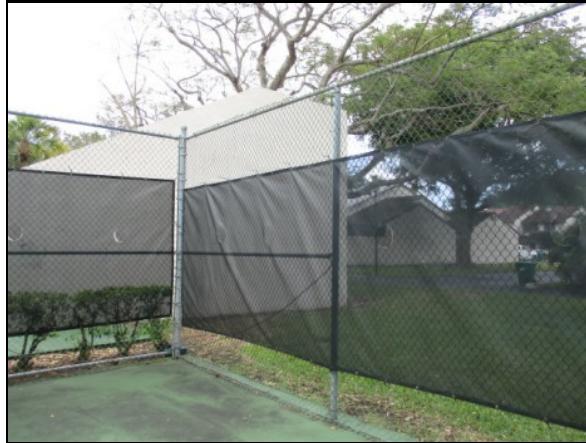
Tennis court fencing should have a long life expectancy assuming proper design and installation, lack of vandalism/abuse, etc. Vinyl-coated chain link fences normally have a longer life expectancy and are more attractive than those without. Gates and locks should be inspected and repaired as needed as an Operating expense in order to restrict access (if desired) to the tennis court. Based on evident conditions, repair/replacement history provided by the Client, and/or original installation date, comprehensive replacement (including framework) is recommended at the approximate interval shown below. Best practice is to coordinate replacement with other major projects, such as court resurfacing, lighting replacement, etc. Costs shown here are based on complete replacement of mesh/fabric as well as poles/framework.

Useful Life:
25 yearsRemaining Life:
0 years
