**Calusa Point Association**  
***Miami, FL***

Report #: 29086-2  
Beginning: January 1, 2023  
Expires: December 31, 2023

**RESERVE STUDY**  
**Update "With-Site-Visit"**

October 26, 2022

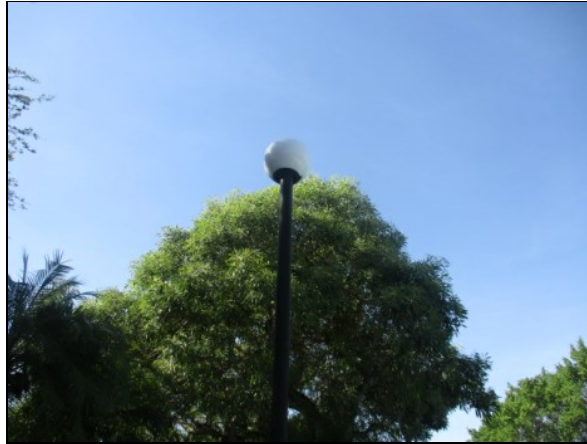
**Comp #: 2772 Pool Deck Lighting - Replace**

Comments: Old, outdated design, poles appeared to be recently painted. The Board of Directors reports that the wiring and electrical panel for these lights may also need replacement, so cost estimates have been updated accordingly. Project is to be deferred according to the Board of Directors.

Fair condition: Pool deck lights determined to be in fair condition typically exhibit somewhat faded/worn appearance but overall assembly is sturdy and aging normally. Serviceable physical condition and still appropriate for aesthetic standards.

Lighting around the pool deck should be inspected regularly to ensure adequate brightness at night for safety precaution. Minor repairs and individual replacements are expected to be handled through the Operating budget. Comprehensive replacement is often coordinated with either exterior/site lighting or with other pool-related components such as decking/fencing. Cost estimates shown below are based on replacement with comparable size and design standards as existing lighting.

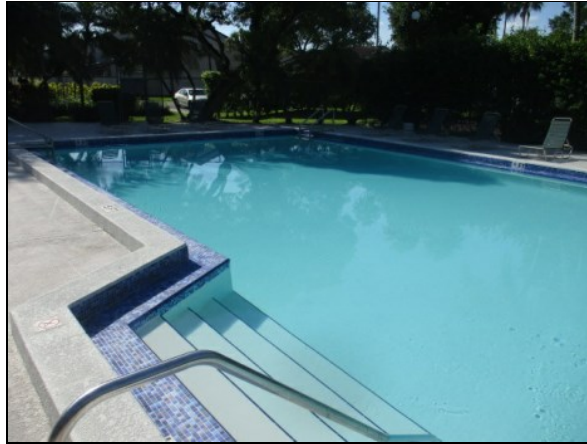
Fair condition: Swimming pools determined to be in fair condition typically exhibit some color fade/discoloration, and roughening of the surface, often more noticeable in the shallow areas and/or at steps. Waterline tiles are in fair condition. Generally believed to be aging normally.

Pool resurfacing will restore the aesthetic quality of the pool while protecting the actual concrete shell of the pool from deterioration. While drained for resurfacing, any other repairs to lighting, handrails, stairs, ladders, etc. should be conducted as needed. This type of project is best suited for slow/offseason to minimize downtime during periods when pool is used heavily. Should be expected at the approximate interval shown below; in some cases, schedule may need to be accelerated due to improper chemical balances or aesthetic preferences of the Client.

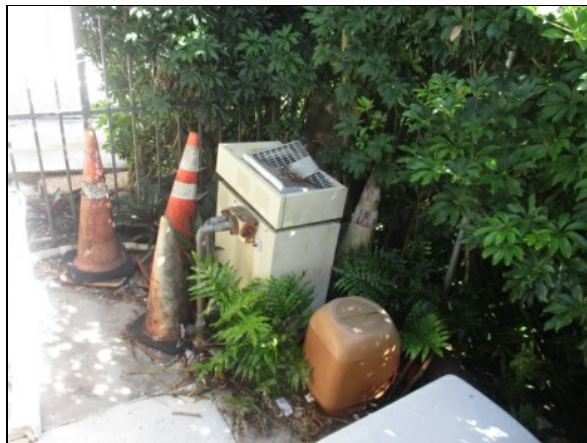
**Comp #: 2781 Spa Heater - Replace****Quantity: (1) Heater**

Comments: Appeared to be approximately 250,000 BTU. This heater is reportedly for the spa which is no longer in use. No need for replacement.

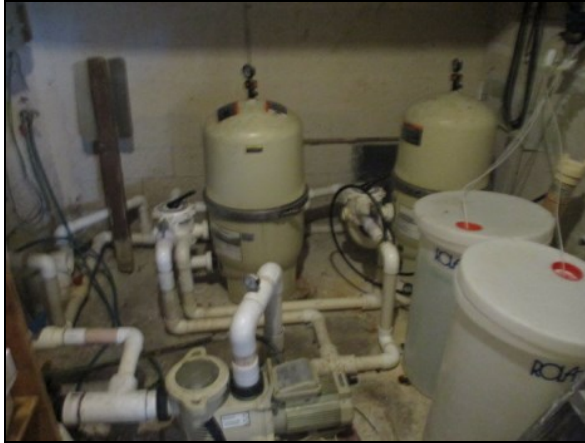
**Comp #: 2787 Pool Equipment - Maintain/Replace**

Minimal or no subjective/aesthetic value for pool and spa equipment. Pool and spa pumps, filters, chemical feeders, and other miscellaneous equipment can be repaired or replaced for relatively low cost in most cases. Due to varying ages and/or information provided during this inspection, comprehensive replacement of all equipment at once is not anticipated. Thus, this component represents a "supplemental" allowance to repair, rebuild, and/or replace equipment as needed. Remaining useful life has been adjusted based on available visual condition, manufacture dates (if available), and/or Client cost history provided. The Client should continually track relevant repair/replacement expenses and report them during future Reserve Study updates. This component should then be re-evaluated based on the most current information available at that time.

Lower allowance to repair/replace equipment

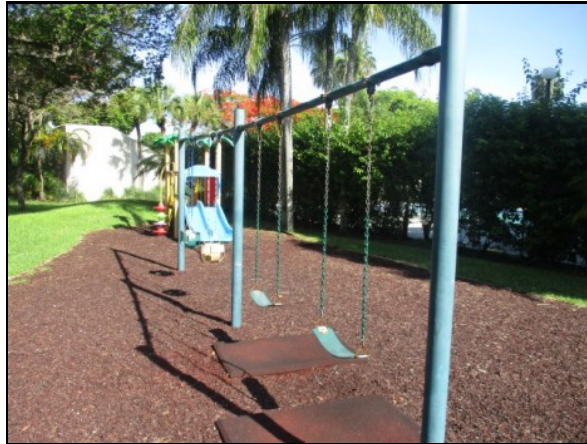
**Comp #: 2801 Playground Equipment - Replace**

Fair condition: Playground equipment/features determined to be in fair condition typically exhibit normal, routine signs of wear and tear and weathering, but no advanced deterioration. Equipment and features are serviceable, but some parts may begin to require replacement, especially if used heavily. Appearance is satisfactory at this stage.

Our inspection is not intended to identify any structural or latent defects, safety hazards, or other liability concerns. Funding recommendation and observations shown here are strictly for budget purposes. As a routine maintenance expense, inspect for stability, damage and excessive wear and utilize maintenance funds for any repairs needed between replacement cycles. Life expectancy can vary depending on the amount of use/abuse. Unless otherwise noted, cost estimates assume replacement would be with comparable size and style of equipment as noted during inspection.

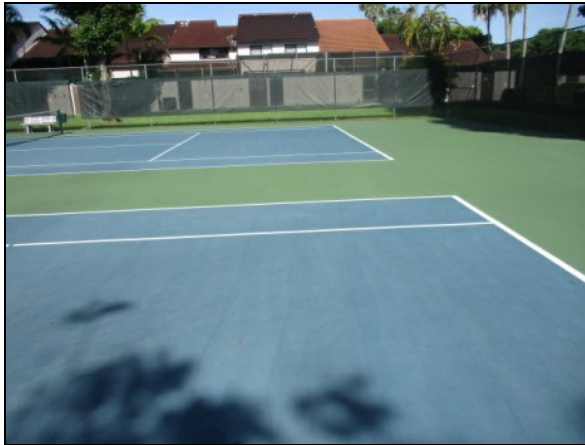
Comments: (2) Tennis Courts and (1) Basketball/Outdoor Racquetball Court, approximately the same size as a tennis court, were observed at the time of inspection.
